Bexar County Courthouse Monitoring/Restoration, San Antonio, Bexar County, Texas

Antonia L. Figueroa and Jason B. Perez

Texas Antiquities Permit No. 7065

Prepared by:
Center for Archaeological Research
The University of Texas at San Antonio
One UTSA Circle
San Antonio, Texas 78249-1644
Archaeological Report, No. 447

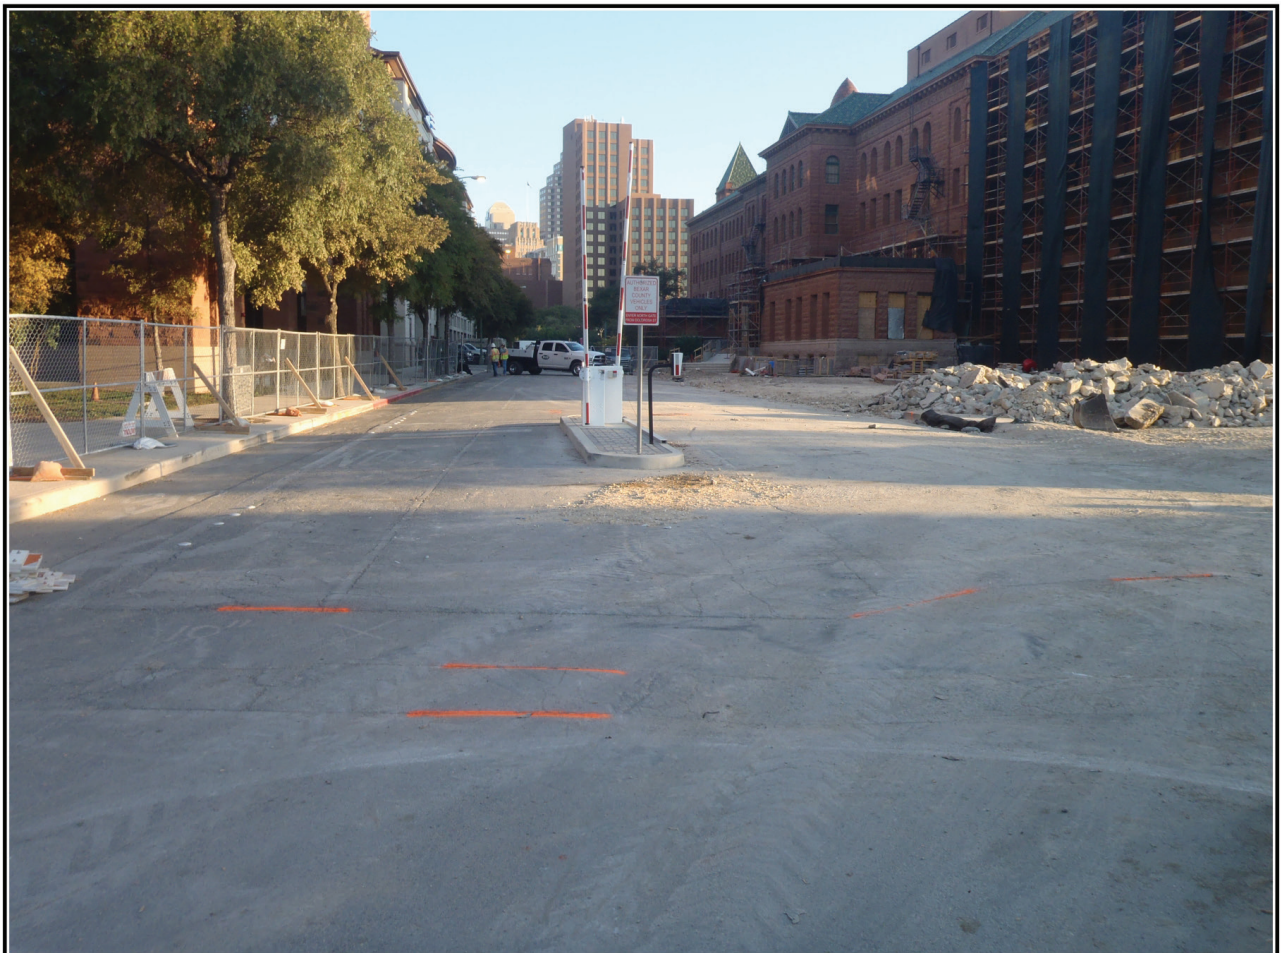
Figure 4-1. Southern portion of Section 1 (facing north).

and copper electrical lines that provided power to the entrance/exit arms situated at the entrance to the street. Throughout the area, cement pads were used to protect underground utilities. These cement pads were initially left in place, however, they were eventually removed by the D&D crew. During this time, no features were found within the area. Artifacts documented, but not collected, included one horseshoe (21 cm below the asphalt) and a few ceramics, including edgeware. Figure 4-1 shows the southern boundaries of Section 1.

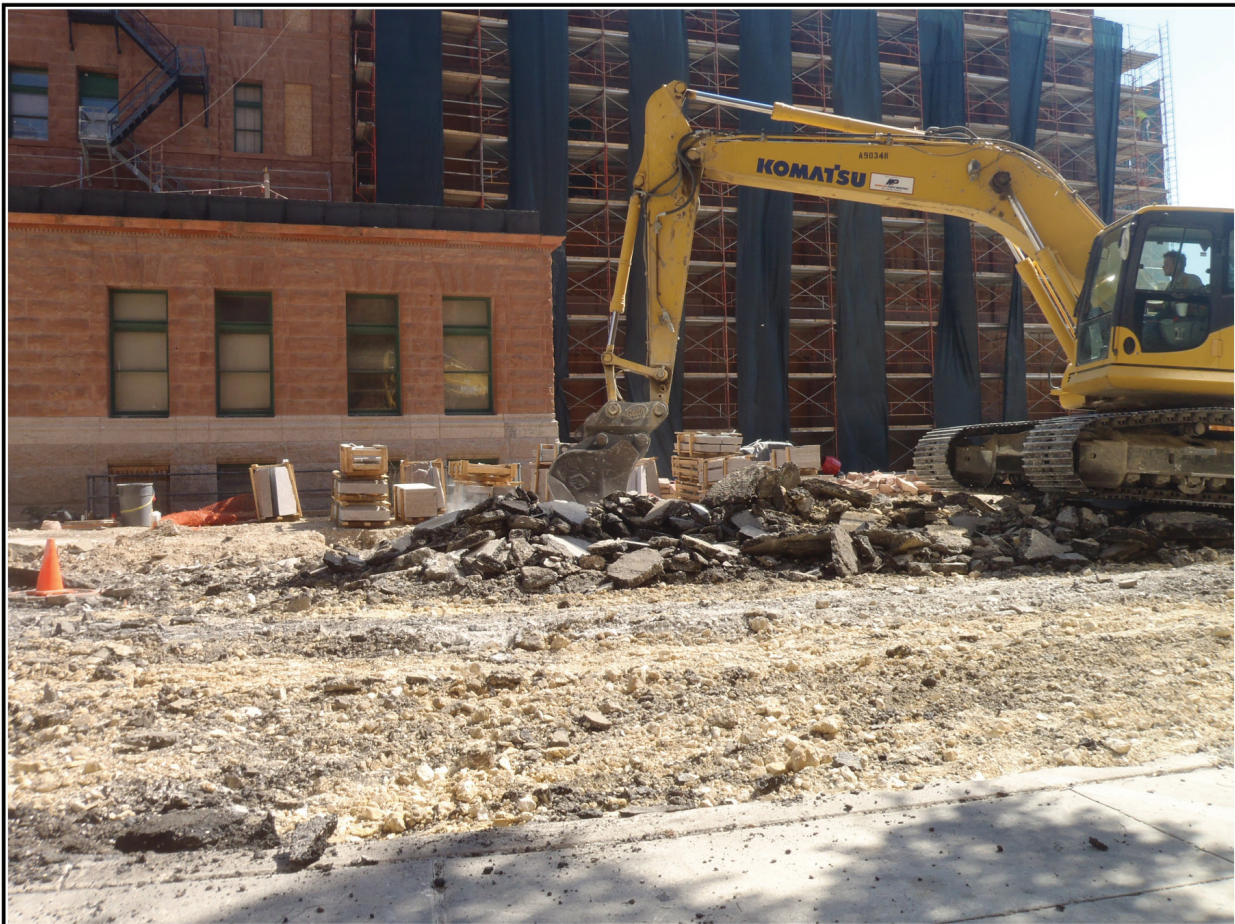
Figure 4-2. Removal of asphalt of Section 2 (facing east).

The first phase of the process consisted of an excavator removing soil using a bucket with a maximum capacity of 1.20 m³ (Figure 4-2). After the initial removal of soil, a wheel loader

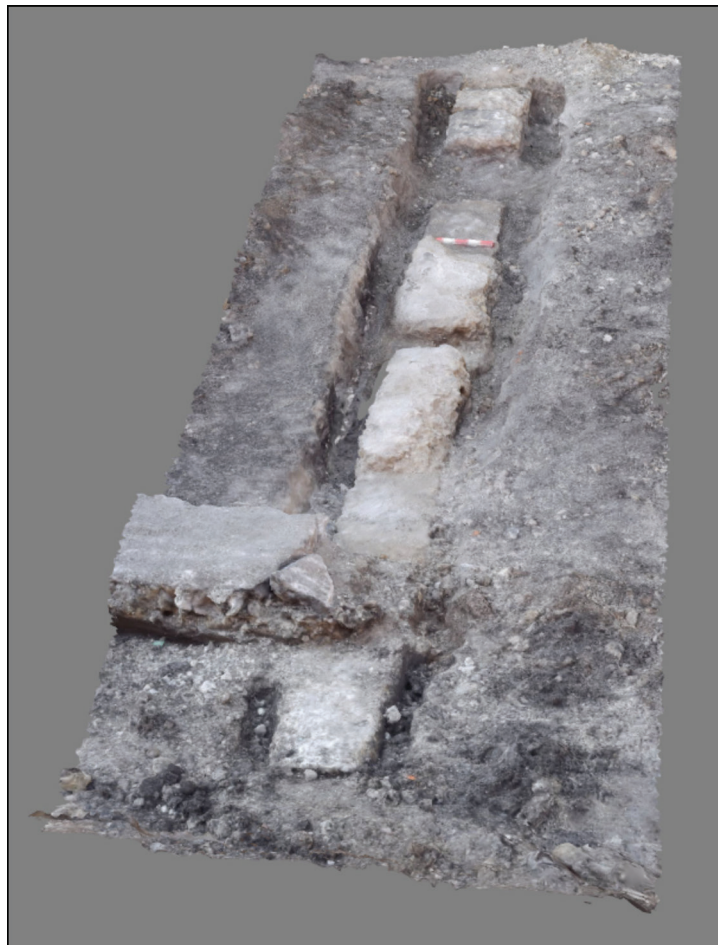
Figure 4-4. 3-D imaging of Feature 1.

The feature was a foundation that consisted of small limestone rocks with a sandy mortar paste (Figure 4-4). The foundation had a variable thickness due to multiple portions being removed by previous excavations, including the probable placement of the gas lines that went north to south across the entire roadway. The western portion of the feature was covered in concrete, and the eastern portion of the feature had a concrete pad that went across it in a north to south direction. While excavating along the edges of Feature 1, artifacts were collected in the soil on both the northern and southern section of the foundation (Figure 4-5). These artifacts are listed in Table 4-2 and suggest a late nineteenth-century affiliation.

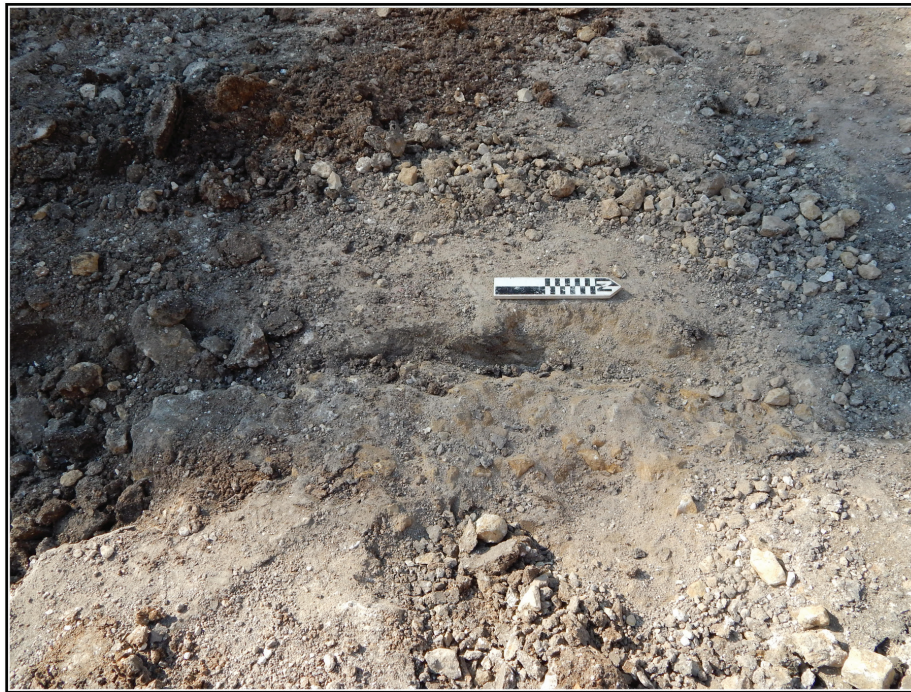
Figure 4-6. Feature 2 (facing west).

Feature 2 consisted of a foundation segment (0.50-x-0.10 m) aligned in a north to south direction (Figure 4-6). Feature 2 was found at a depth of 48.26 cm below the surface (cmbs). The foundation was made from limestone material similar to that of Feature 1. Feature 2 appears to be the remnants of a foundation, as multiple segments of foundation going in the same direction and in the same alignment were found in the middle section of the APE. Artifacts directly associated with Feature 2 consisted of glass (Table 4-3), with one diagnostic artifact, a NuGrape soda bottle, dating between 1915 and 1924 (Clinton M. M. McKenzie, personal communication 2015). Feature 2 was reburied with soil and left in place.

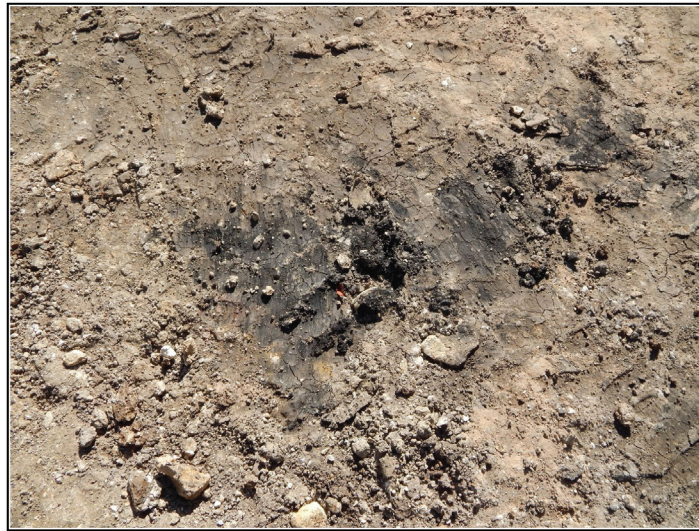
Figure 4-7. *Feature 3.*

Feature 3 consisted of a charcoal stain 0.30-x-0.30 m in size and located 50.80 cmbs (Figure 4-7). There were no artifacts associated with the stain, and no excavation was performed. Feature 3 was left in place.

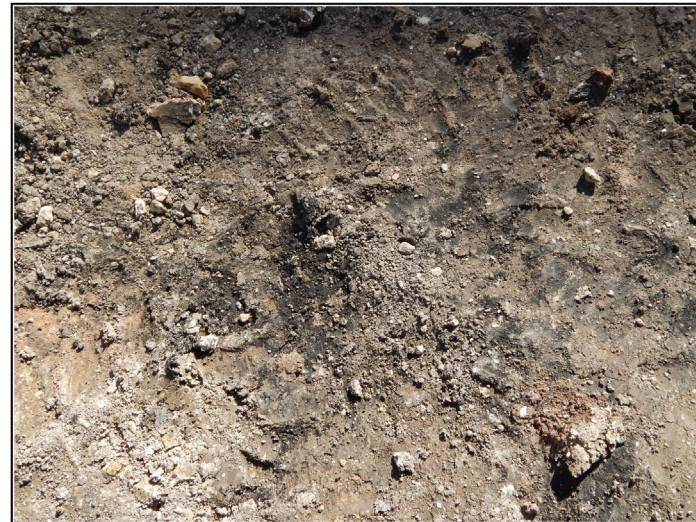
Figure 4-8. *Feature 4.*

Feature 4 consisted of a charcoal stain 0.20-x-0.20 m in size and located 50.80 cmbs (Figure 4-8). There were no artifacts associated with the stain, and no excavation was performed. Feature 4 was left in place.

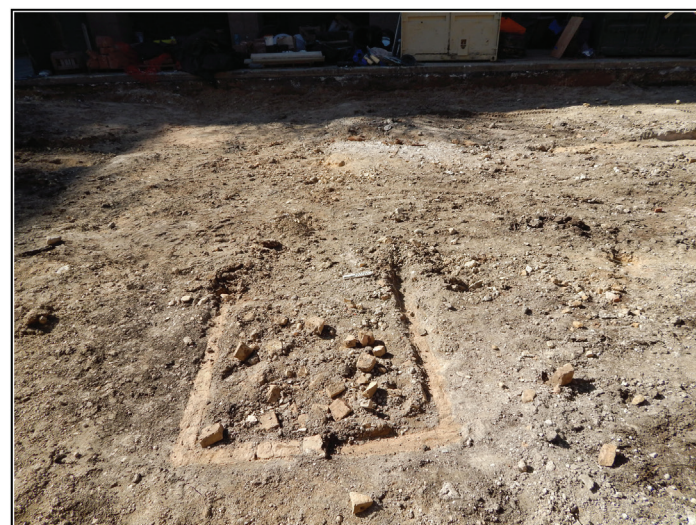
Feature 5 consisted of a privy that was lined with handmade bricks (Figure 4-9). The bricks were laid out in a U-shaped pattern with the base of the U going in a north to south direction. The feature measured 0.80-x-0.70-x-0.12 m and was located 48.26 cmbs. The bricks were double stacked, at least. No further depth was excavated, and the bricks were preserved in place. CAR staff interpreted this feature to be a privy associated with the St. Leonard's Hotel. Privies with similar characteristics were identified during the Alamodome project (Brown and DelaO 1997). No artifacts were directly associated with Feature 5.

Figure 4-9. *Feature 5, a brick lined privy.*

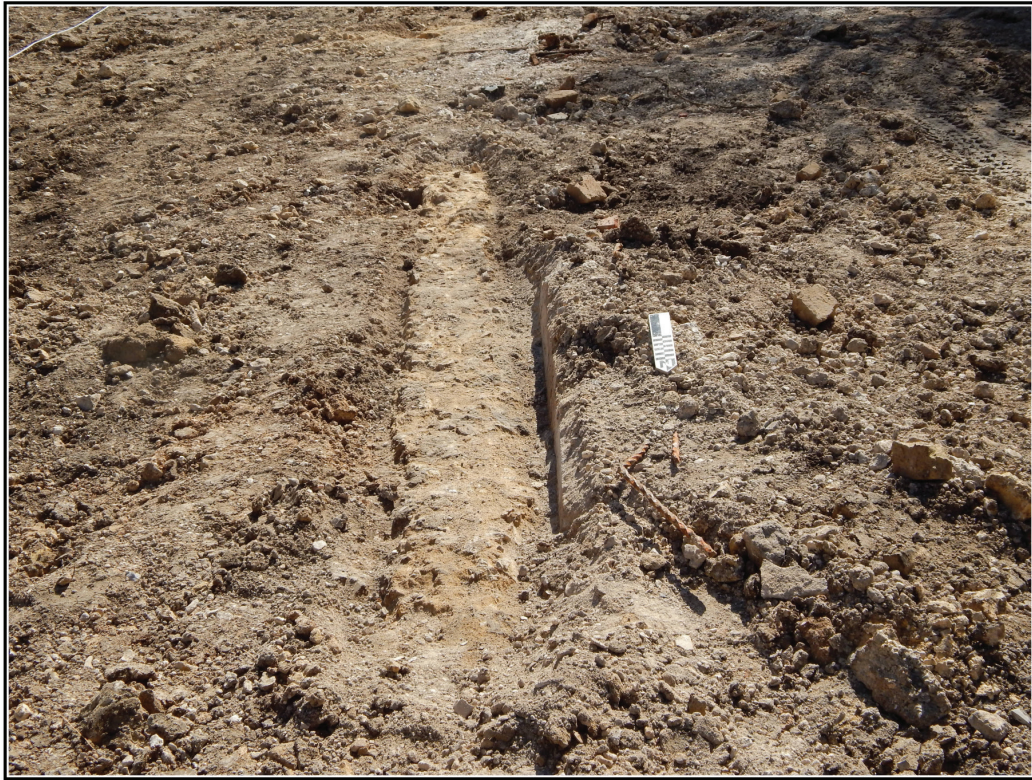
Figure 4-11. *Feature 8 (facing south).*

Feature 8 consisted of a foundation segment (1.50-x-0.10 m) and was aligned in a north to south direction (Figure 4-11). The feature was in line with the segment from Features 2 and 6. Feature 8 was found at a depth of 48.26 cmbs. The foundation was made from the same material as Feature 1. No artifacts were directly associated with this feature. Feature 8 was reburied with soil and preserved in place.

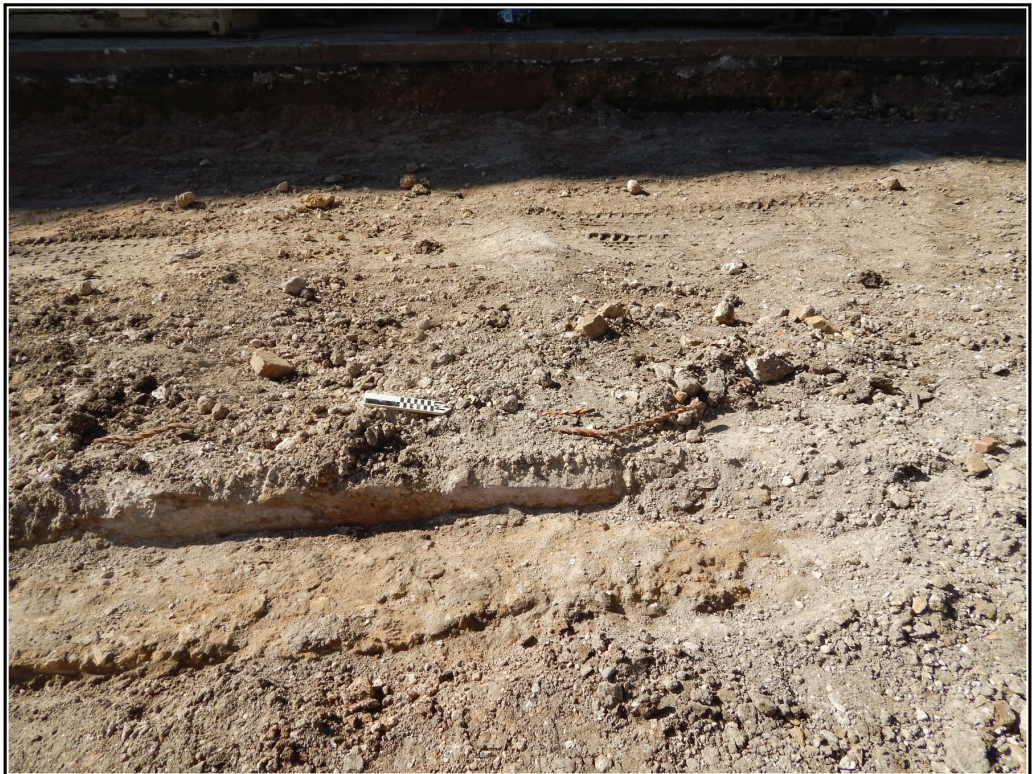
Figure 4-12. *Features 9 and 10 (facing west).*

Feature 9 (1.70-x-0.20 m) and Feature 10 (0.90-x-0.10 m) consisted of a cement and rebar foundation in the same style as Feature 7. The features ran parallel to each other in an east to west alignment and were perpendicular to Feature 8. Features 9 and 10 were approximately 40 cm apart from each other (Figure 4-12). Both features were above the desired level of the APE excavation and were skimmed down to 50.80 cmbs. No artifacts were associated with Feature 9 or Feature 10.

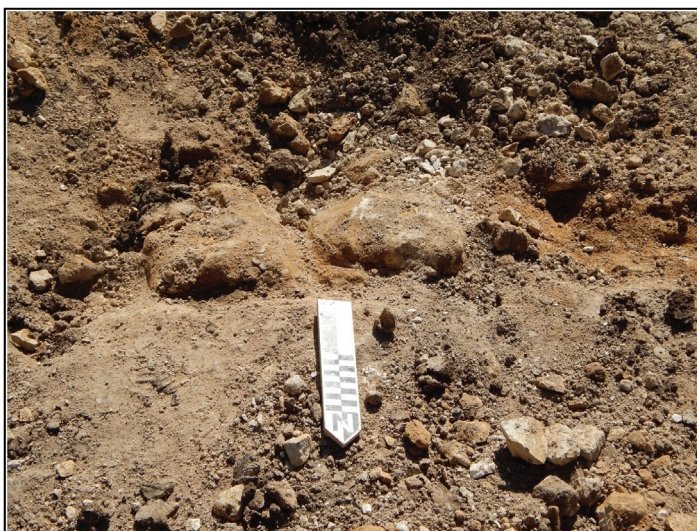
Figure 4-13. Feature 11 (facing south).

Feature 11 consisted of two large limestone blocks (Figure 4-13). Both blocks were approximately 15 cm across at their widest dimension. The feature was found at a depth of 50.80 cmbs. No artifacts were directly associated with Feature 11, and it did not align with any of the other features. Feature 11 was reburied with soil and left in place.

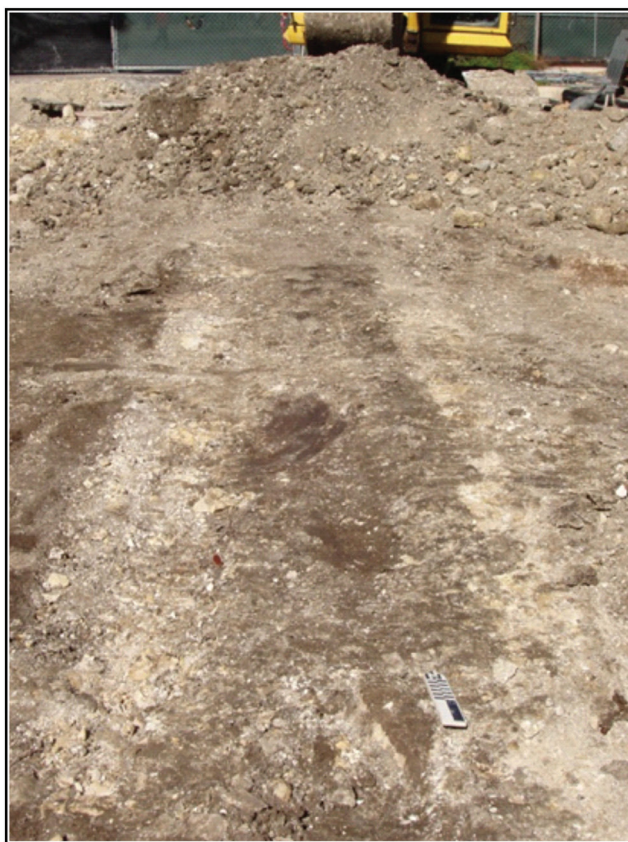
Figure 4-14. Features 12 and 13 (facing north).

Features 12 and 13 consisted of two strips of probable foundation that were similar in appearance to the other limestone rock foundations identified on the project area (Figure 4-14). The foundation was made from limestone. Features 12 and 13 were found at the surface of 50.80 cm. Both

features were approximately 5 cm in width. Feature 12 was 3.50 m in length. Feature 13 was broken into two sections with the southern section measuring 2 m in length and the northern section 1.60 m in length. Neither feature was in alignment with any of the previous features, and both were at a lower depth than other features. No artifacts were associated with Feature 12 or Feature 13. The features were left in place.

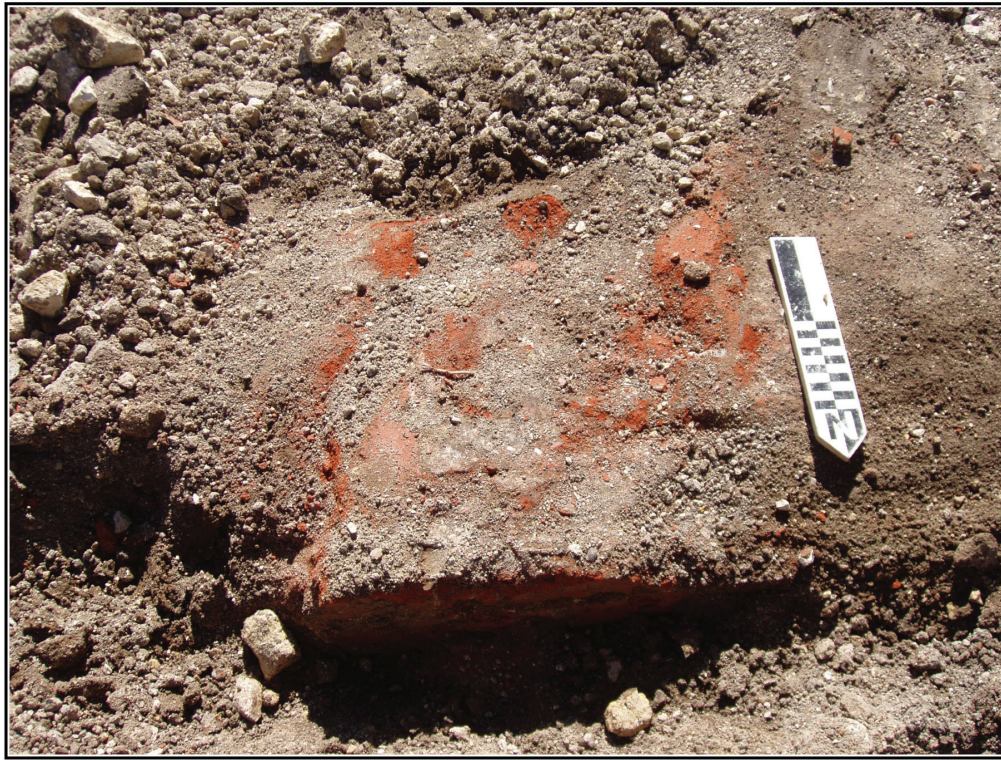
Figure 4-15. Feature 14 (facing south).

Feature 14 consisted of a brick “pier” corner (0.30-x-0.30 m) and was 45.72 cmbs (Figure 4-15). The feature was not associated with any other feature or with any artifacts. Feature 14 was reburied and left undisturbed.
